**TREES AT ROYSDEAN MANOR, 5 DERBY ROAD, BOURNEMOUTH, BH1 3PT.**

Survey trees that have a potential impact on the proposed erecting of fencing at Roysdean Manor, 5 Derby Road, Bournemouth, BH1 3PT, from the plans provided. Comment upon their condition, suitability for retention and the impact they may have upon the proposed fencing.

**Date of Inspection:** 10.07.25

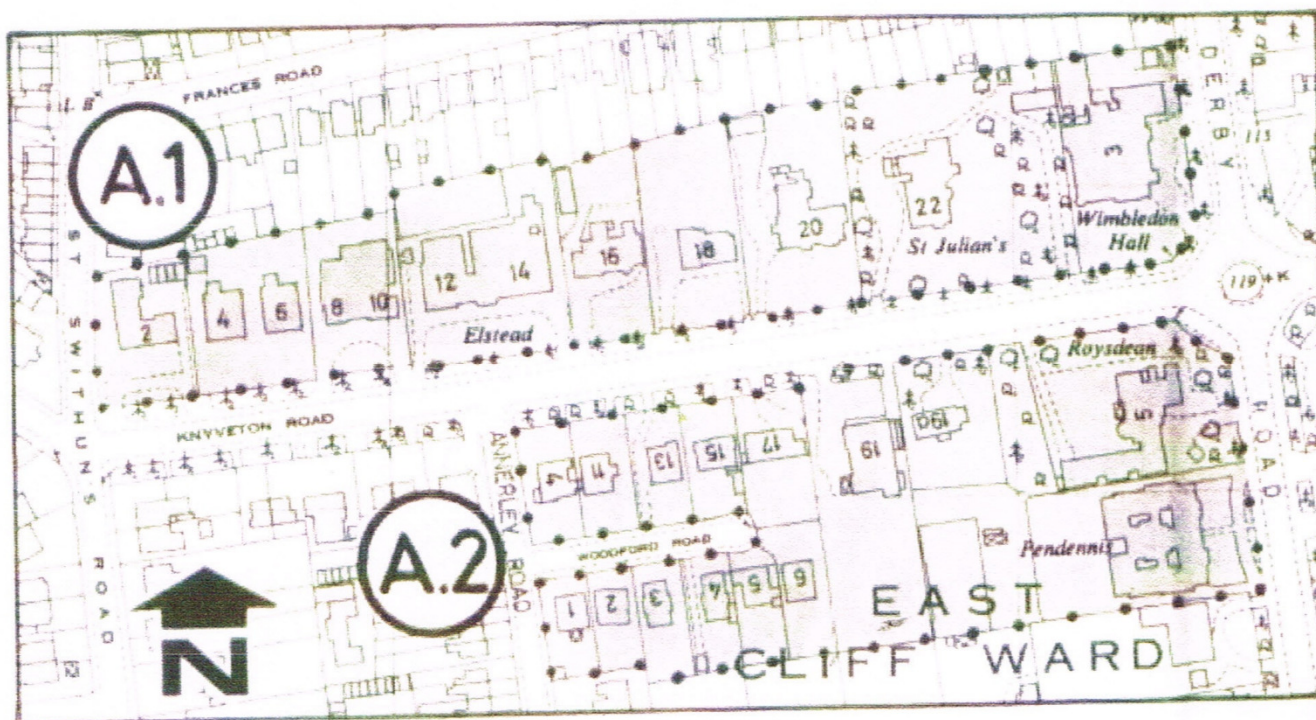
The site is currently covered by an Area Tree Preservation Order (TPO). Area TPO 1971 Knyveton Road, Woodford Road and Derby Road, reference E114 protects the trees on the site named in the report as A2. The trees covered are "*The numerous trees of whatever species standing within the area bounded by the dotted black lines.*"

Image 1 below shows the location of the dotted black line that includes Roysdean Manor, 5 Derby Road, Bournemouth, BH1 3PT.

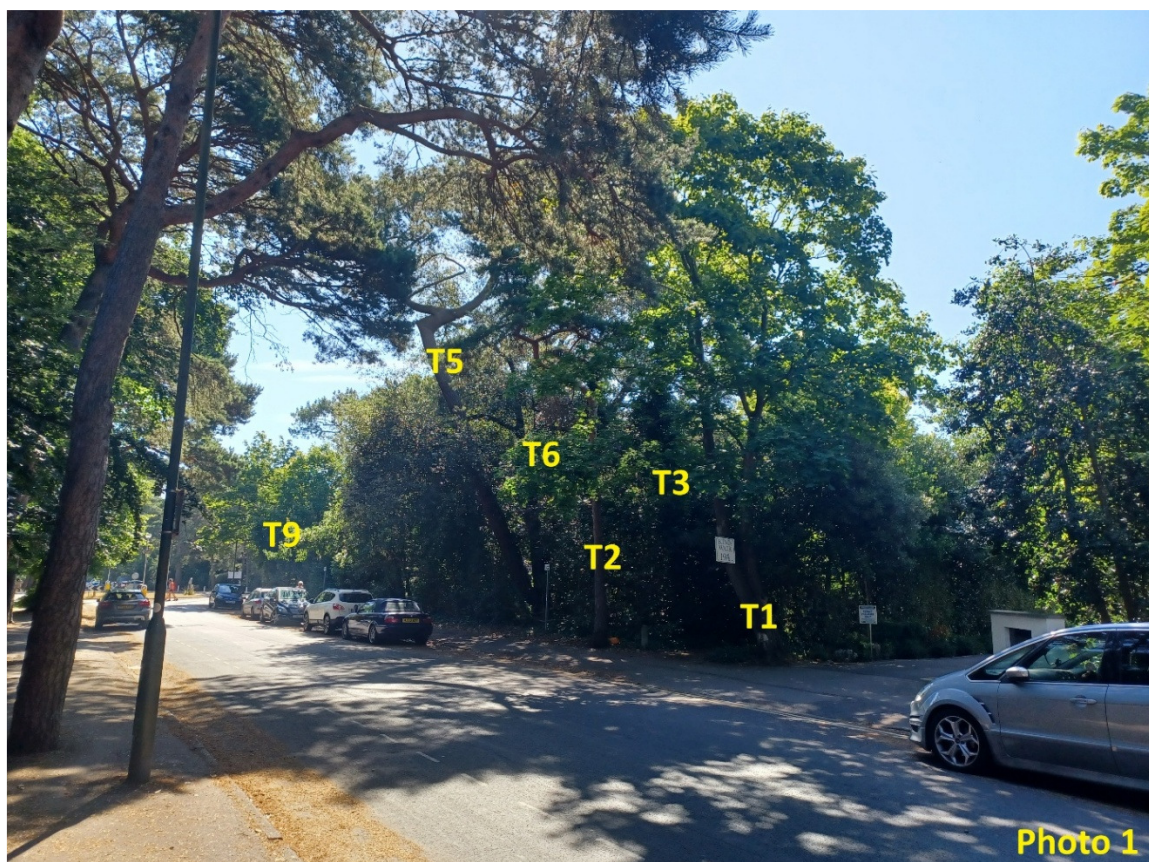
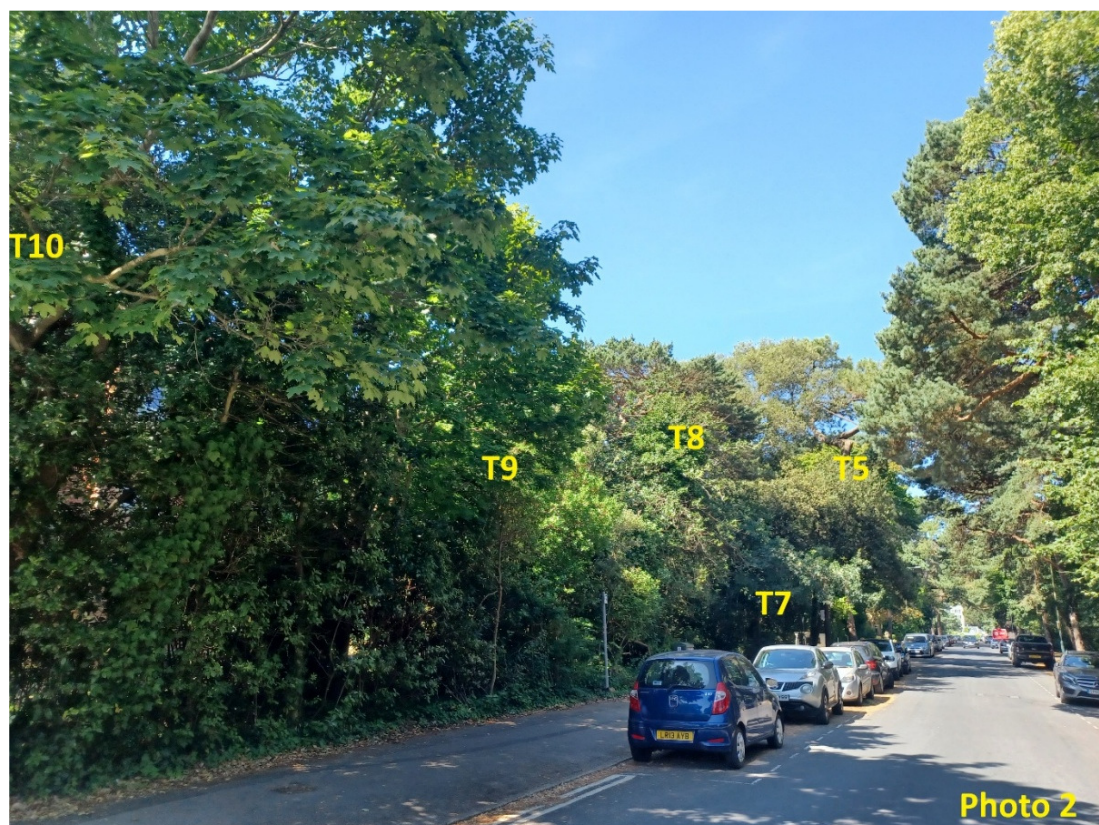
The enclosed tree survey plan indicates the initial root protection areas produced from the survey data. The Root Protection Areas (RPAs) for the trees have been calculated using the formula given in BS5837:2012. This is the recommended area around the tree in square metres within which no construction, excavation, soil stripping, level changes or other potentially harmful activities should take place unless appropriate precautions or techniques are employed to avoid root damage. Barriers should protect this area for the duration of any development works to avoid damage to the root system.

From the plans provided of the proposed erection of fencing at Roysdean Manor, 5 Derby Road, Bournemouth, BH1 3PT, T1, T2, T5, T6, T7 and T8 are potentially impacted, as shown on drawing 7741. T3 and T4 are not a consideration as they have been categorised as U; they are standing dead trees.

To erect the fencing in a way that has the least impact on the trees the post holes should be no bigger than 300mm in diameter. The post holes should be hand dug to a depth of 600mm and then a mechanical auger can be used to finish off the post holes to the required depth. No roots larger than 25mm should be severed without consultation with the project arborist or local authority tree officer, and if this is authorised, it should be done with a sharp implement to prevent tearing. The position of a post hole will need to be adjusted if it is found that an important structural root dissects the post hole and cannot be severed.

When backfilling the post holes with concrete, the post holes should be lined with a watertight liner that will prevent the leaching out of any compounds. Cement is a calcareous compound which has the ability to modify the pH of the surrounding soil to a level that has the potential to cause harm to the trees, which is why it needs to be contained
