JTEC Environmental

SOUND INSULATION TEST REPORT

Sound Insulation testing in accordance with Test Standard ISO 140-4

This report describes the process taken and the results obtained from the sound insulation testing at 4 The Triangle, Bournemouth, BH2 5RY.

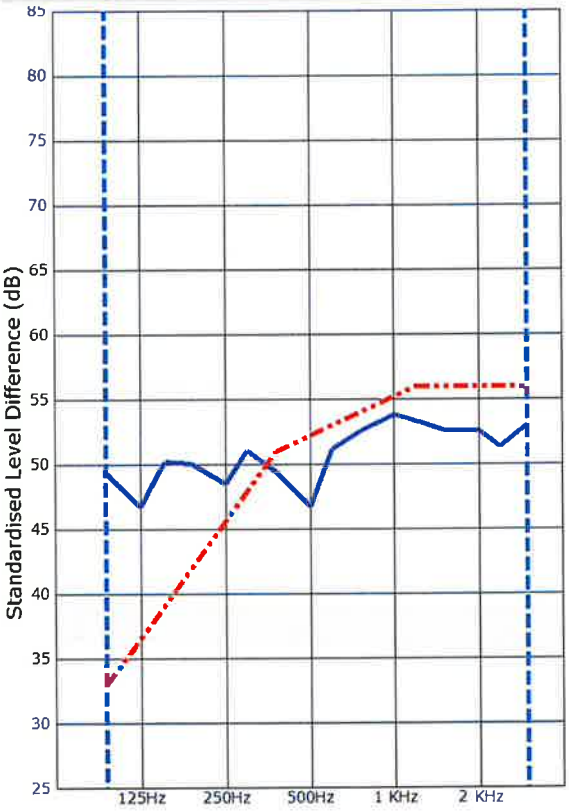
$D_{nT,w}$ (C; C_{tr}) [dB]: 52 (0, -1) dB
$D_{nT,w}$+ C_{tr} [dB]: 51 dB
Minimum Pass Level [dB]: 43 dB

PASS
Adverse Aggregated Deviations [dB]: 28.4

Partition Detail:WB0001** : Generic Masonary BlockWT0001** : Generic Timber Frame

Test Exceptions (if any): Receive Room furnished

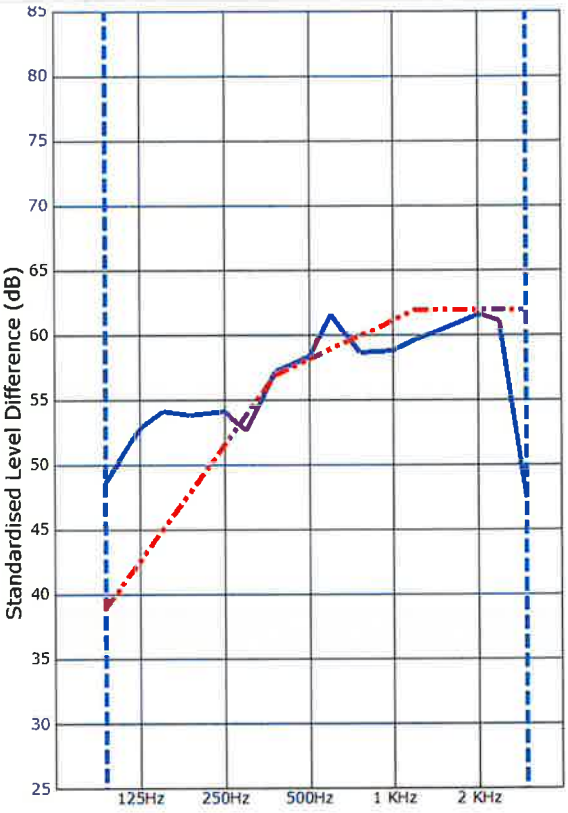
$D_{nT,w}$ (C; C_{tr}) [dB]: 58 (-3, -1) dB
$D_{nT,w}$+ C_{tr} [dB]: 57 dB
Minimum Pass Level [dB]: 43 dB

PASS
Adverse Aggregated Deviations [dB]: 24.5

Partition Detail:WB0001** : Generic Masonary BlockExisting brick wall

Test Exceptions (if any): Source Room furnished, Receive Room furnished

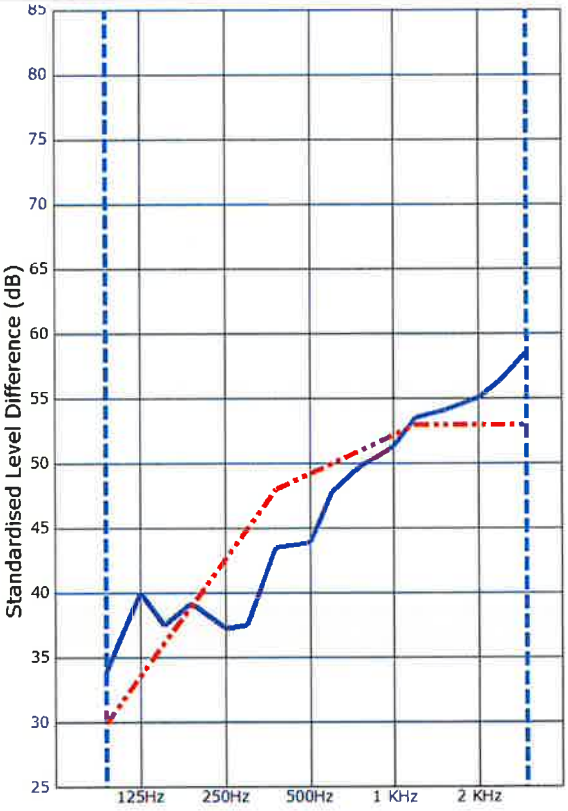
$D_{nT,w}$ (C; C_{tr}) [dB]: 49 (-1, -4) dB
$D_{nT,w}$+ C_{tr} [dB]: 45 dB
Minimum Pass Level [dB]: 43 dB

PASS
Adverse Aggregated Deviations [dB]: 25.8

Partition Detail:FT0001** : Generic Timber JoistFloorboards, timber joist currently exposed when viewed from the ground floor unit

Test Exceptions (if any): Source Room furnished

Sound insulation measures are be implemented and further sound tests carried out after the measures have been implemented.
